## A Survey of Thatched Buildings in Scotland

Thatch Survey of Scotland  
2014-15

A photographic survey of thatched buildings in Scotland, surveyed between May 2014 and August 2015 by Zoe Herbert (SPAB Scotland Officer), on behalf of the Society for the Protection of Ancient Buildings.

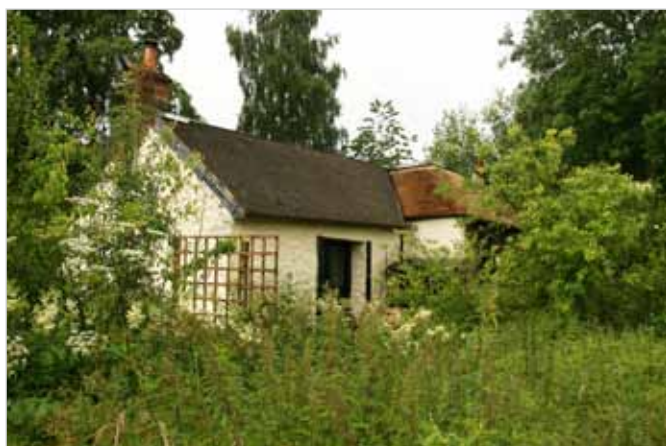
Address: ..... Invermay House

**Additional Notes:** ..... This building is now a roofless ruin. The owner of the land, who owns the nearby Invermay House within the grounds of which the gazebo is located, stated that the building has been in a ruinous condition for many years (the implication being decades). The building was listed in 1981, however it is listed as being a 'ruin' with a 'pyramid thatched roof'. According to the listing description, it was designed by Alexander Laing in 1804.

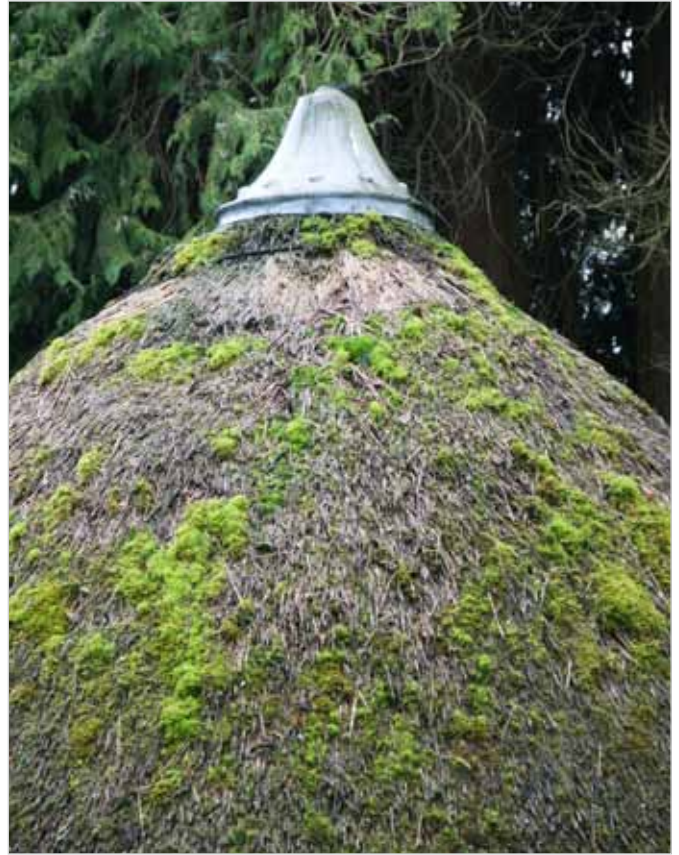
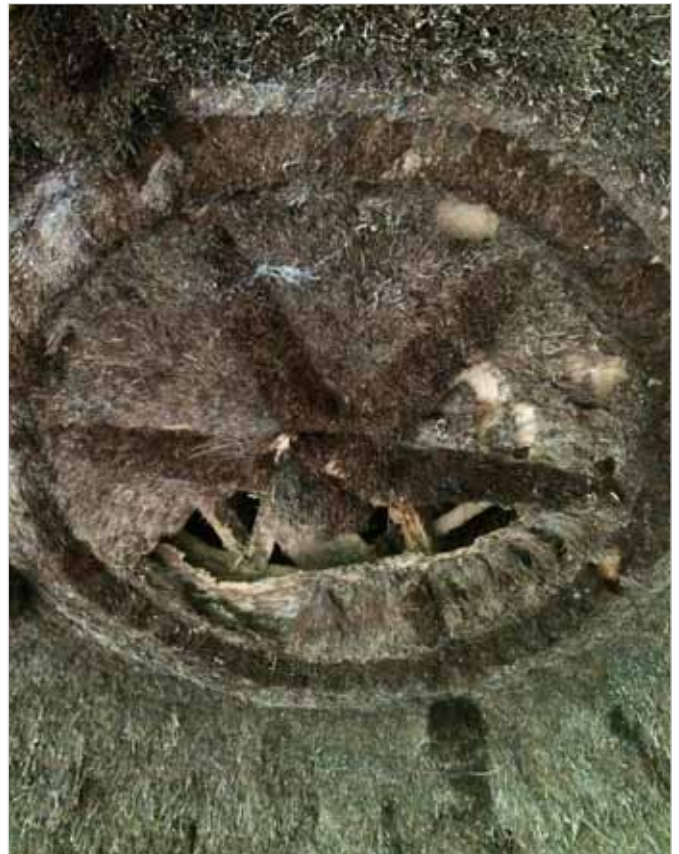
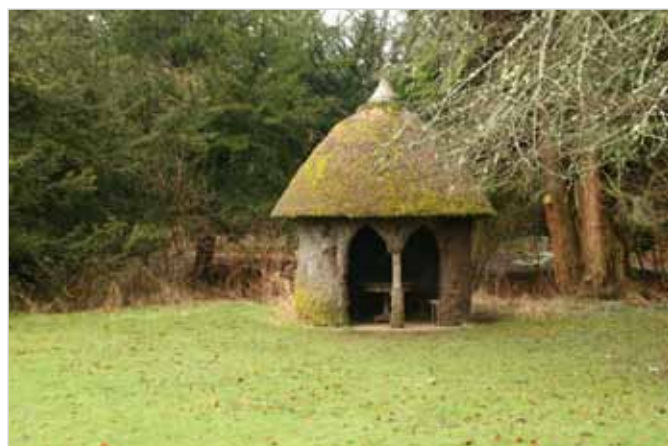
Heather Summerhouse – Scottish Borders

Condition of Thatch: ..... Fair

ceiling with contrasting star detail and ribs. There is some damage to the heather-thatch ceiling, which has exposed

clad in heather, last re-thatched in 1990. There is some damage to the heather externally, with two substantially

sized holes exposing the timber wall structure beneath, as well as a few minor patches of damage to the thatch.

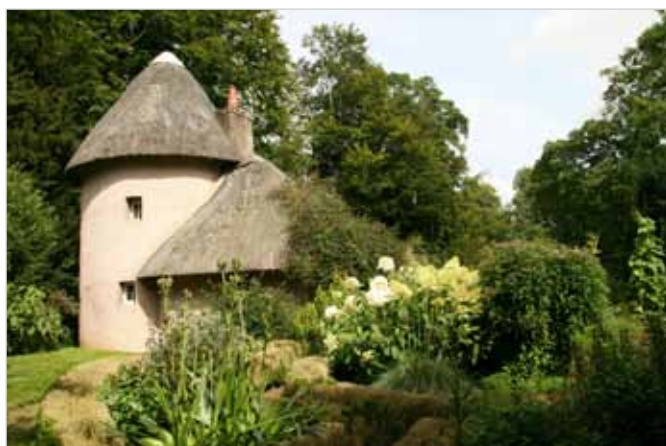
Norman Cottage – Scottish Borders

Condition of Thatch: ..... Fair

**Additional Notes:** The listing description for this building simply reads 'cottage orne in park'. A section of text on Canmore states that the building is late 19th-century. The building, which is also known as 'Old Cottage', currently has a thatched roof to both the main block and the wing to the south. The main block is a circular two-storey structure with a conical thatched roof, whilst the wing has only one storey and a steeply pitched roof. Both sections of the roof are thatched in reed, which is entirely netted. The apex of the conical section of thatch is capped in metal, whilst the lower section of roof has a short ridge of concrete at the point that

it meets the chimney stack. There is some mossy vegetation growth across the surface of the thatch throughout, and vegetation from the garden below has begun to grow up onto the thatched roof of the wing.

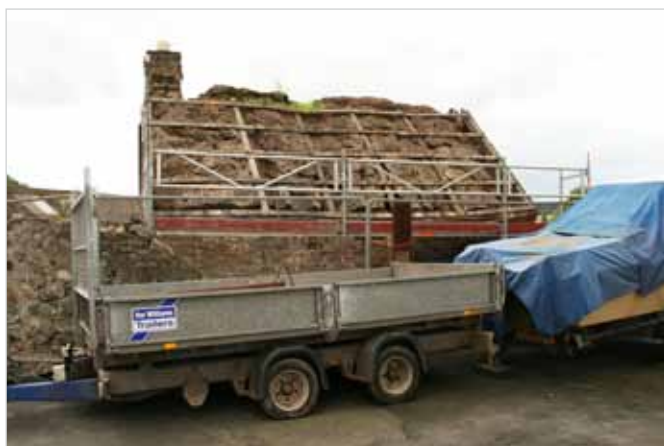
Fluther's Cottage – Scottish Borders

Condition of Thatch: ..... Poor

what type of material the thatch is. The planning application states '*retaining original thatched roof beneath subsequent corrugated iron roof and "boxed" barge-boarding at eaves*'.

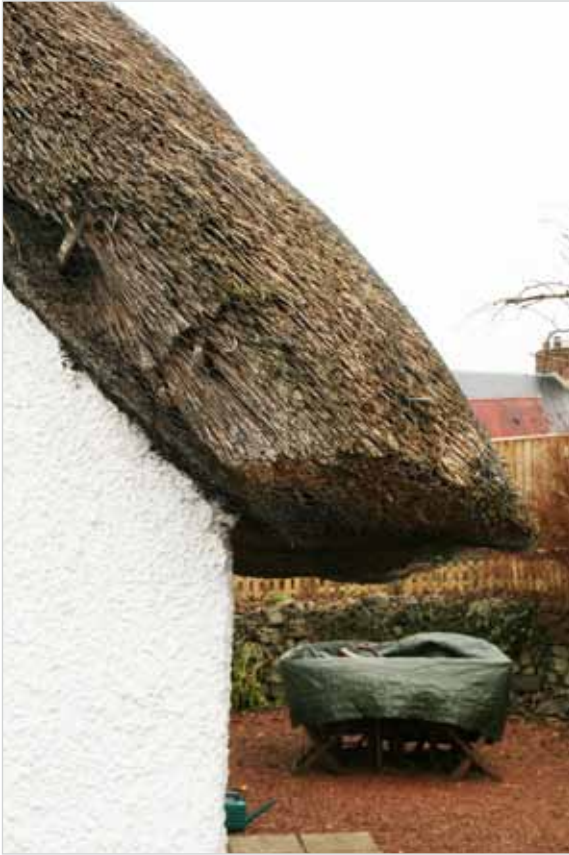
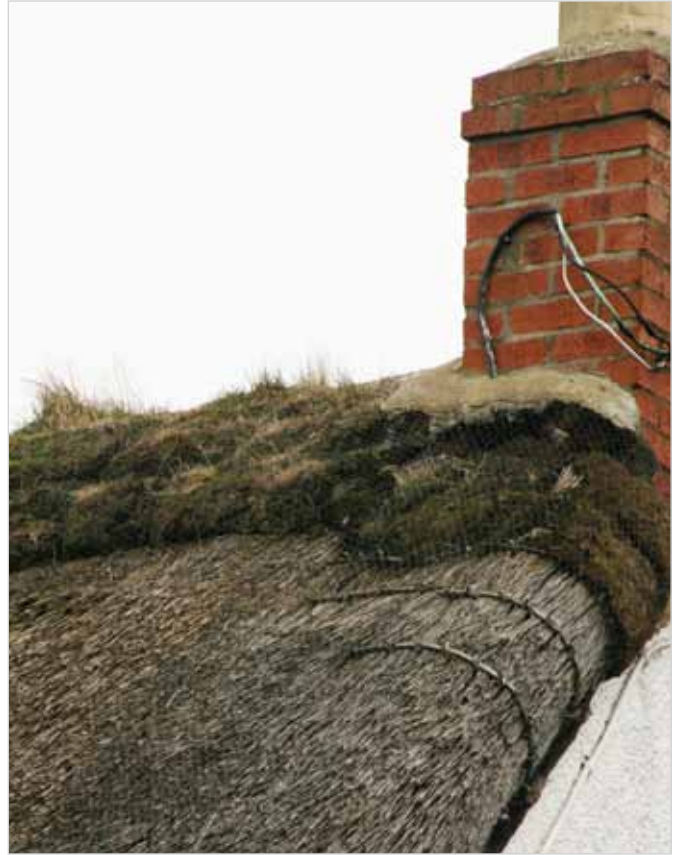
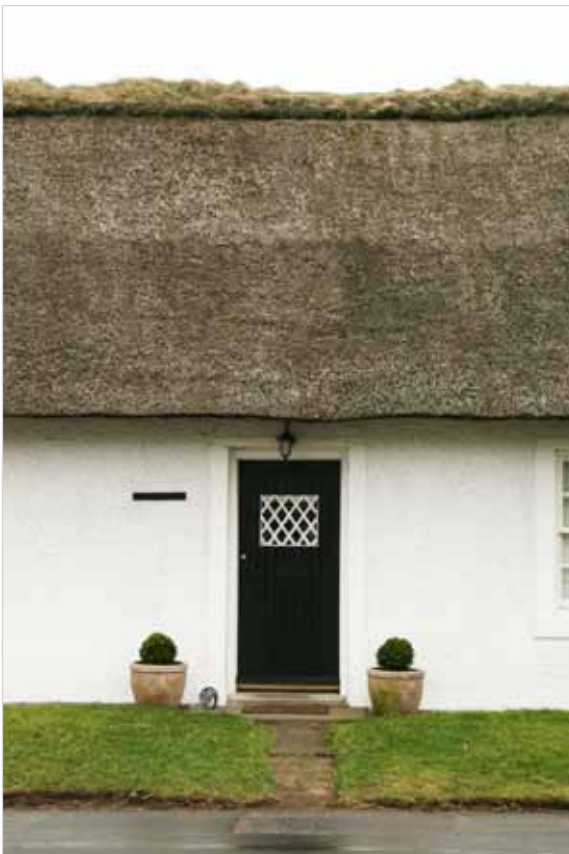
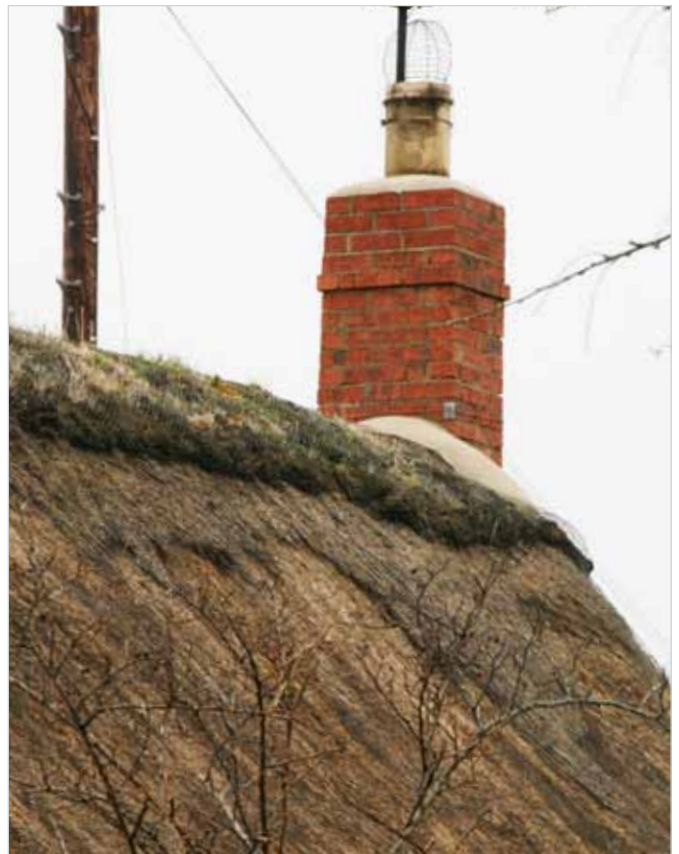
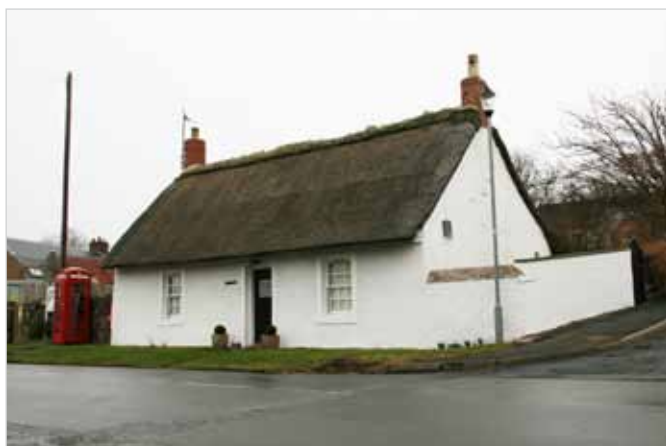
Rowantree Cottage – Scottish Borders

Additional Notes: ..... Late 18th-century single-storey cottage, currently used as a holiday rental, is listed as having a 'thatched roof with scalloped ridging'; however, the ridge is no longer scalloped. It is unclear whether the ridge is thatched in turf or whether this is extensive vegetation growth. The entire thatch, including the ridge, is netted. What appear to be repaired patches are visible directly below the chimney stacks on both the north and south ends on the front (NW) elevation, which have been scobed using hazel. There is also a patch of repair below the south chimney on the rear (SE) elevation, again using spars. The thatch on the front elevation is in good condition;

..... Good

however, on the rear elevation the surface of the thatch appears to be slightly damaged in places.

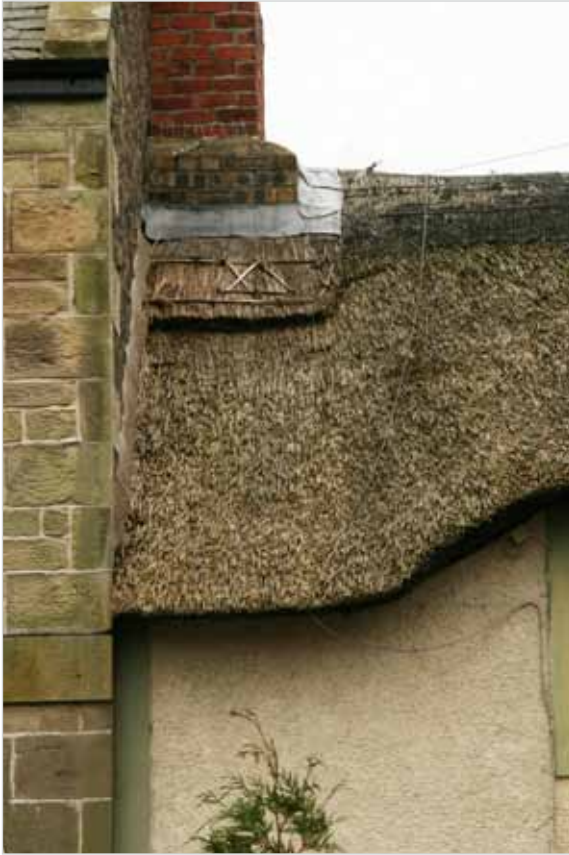
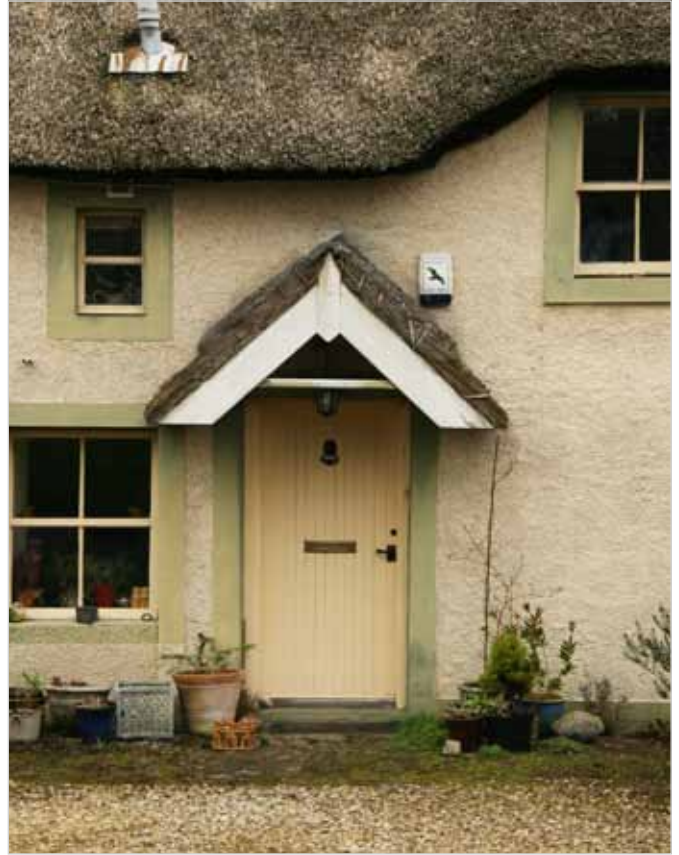
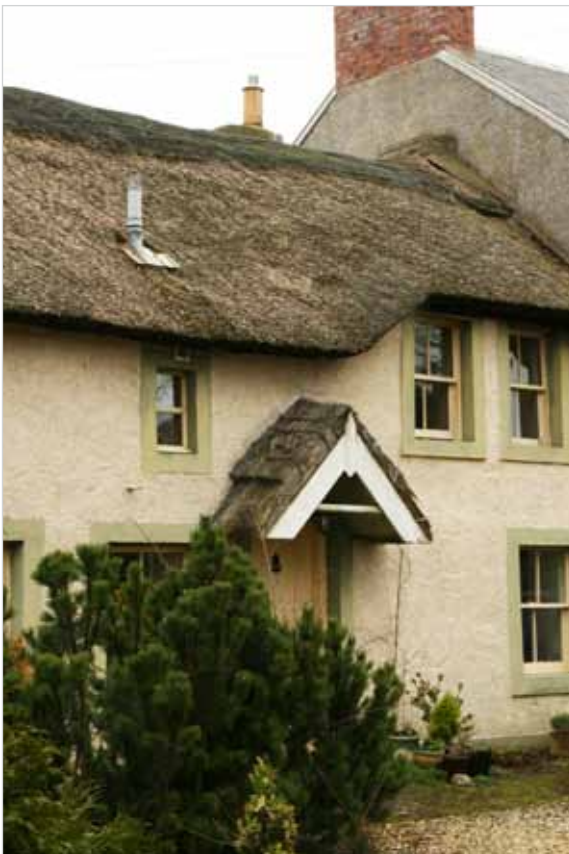
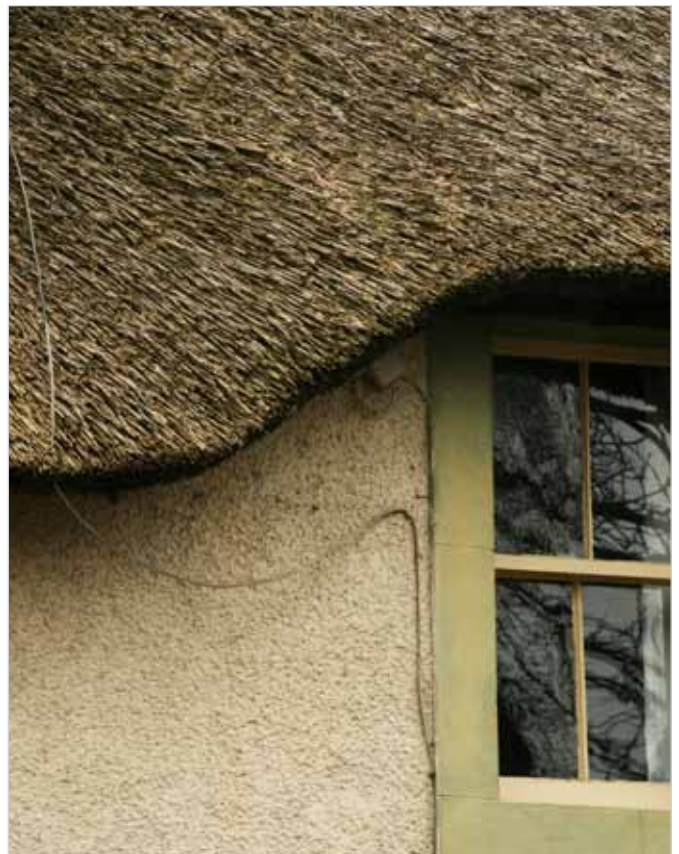
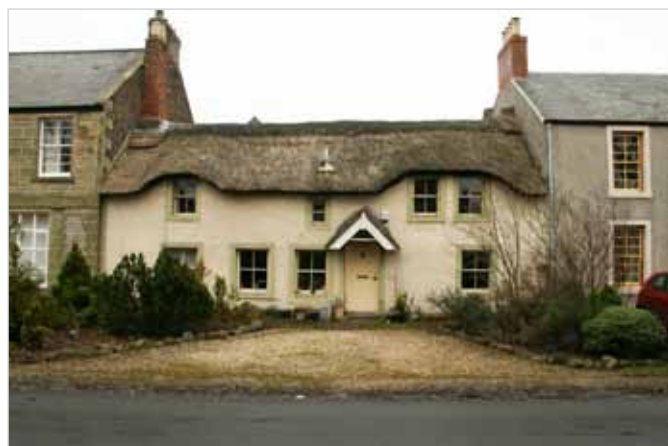
Thatched Cottage – Scottish Borders

Condition of Thatch: ..... Good

more defined below the northern stack. Only the ridge and entrance canopy are netted. The thatch has a small amount of mossy vegetation growth throughout. On the rear elevation, the roof and ridge are both thatched in the same manner as on the front.

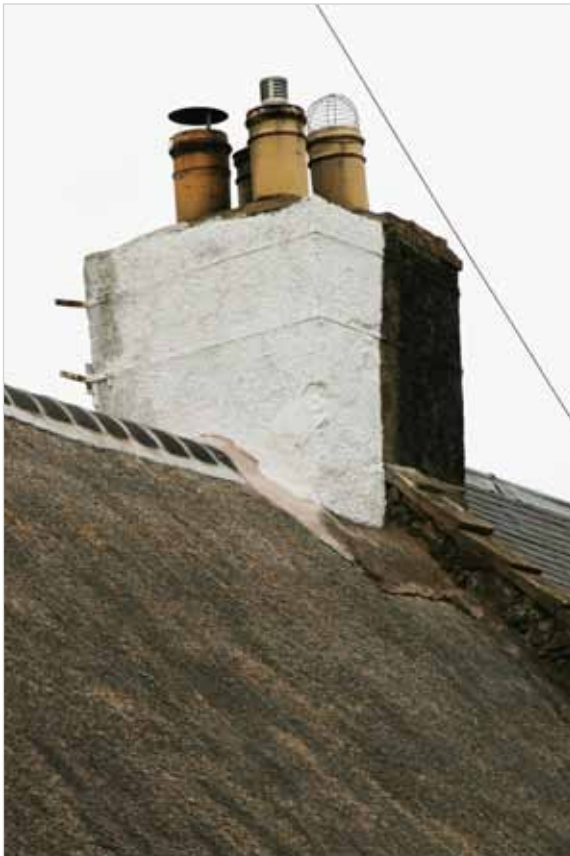
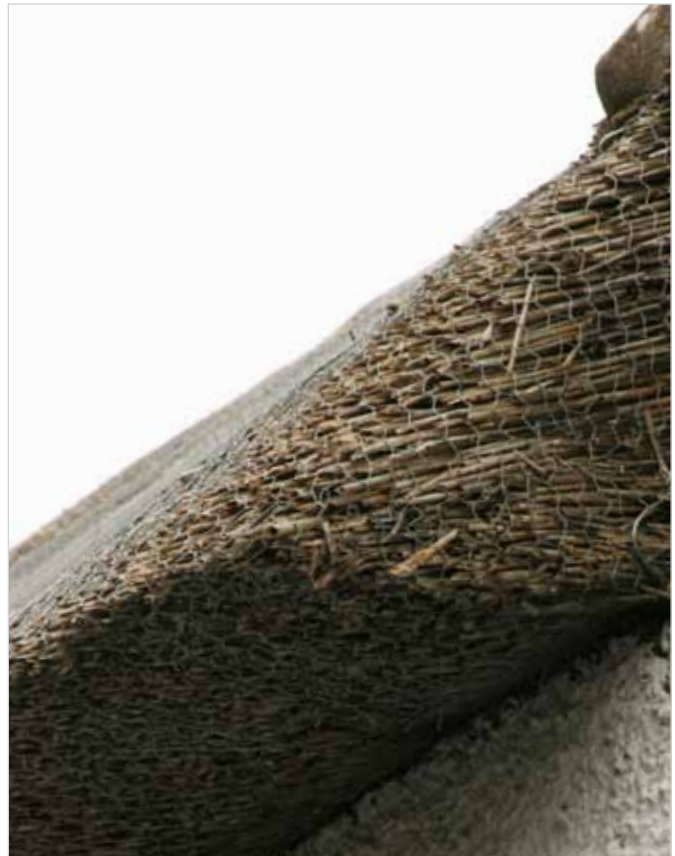
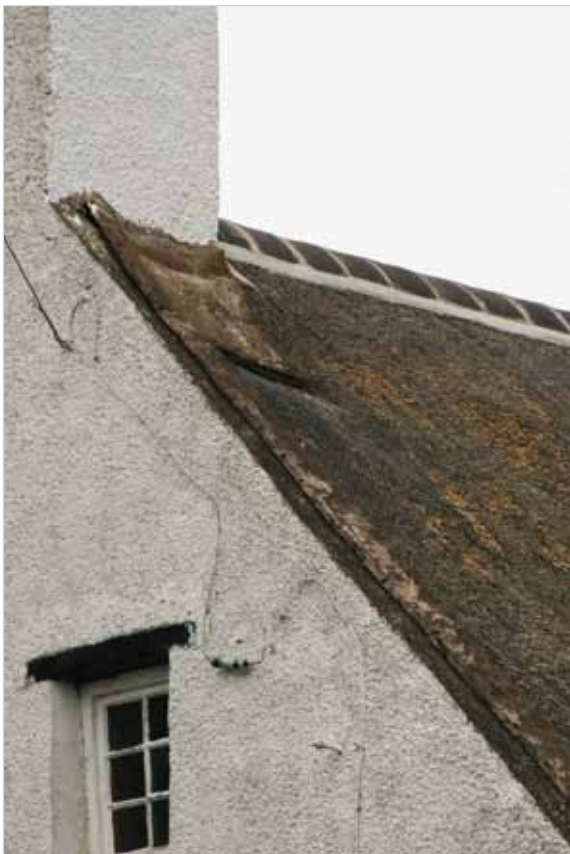
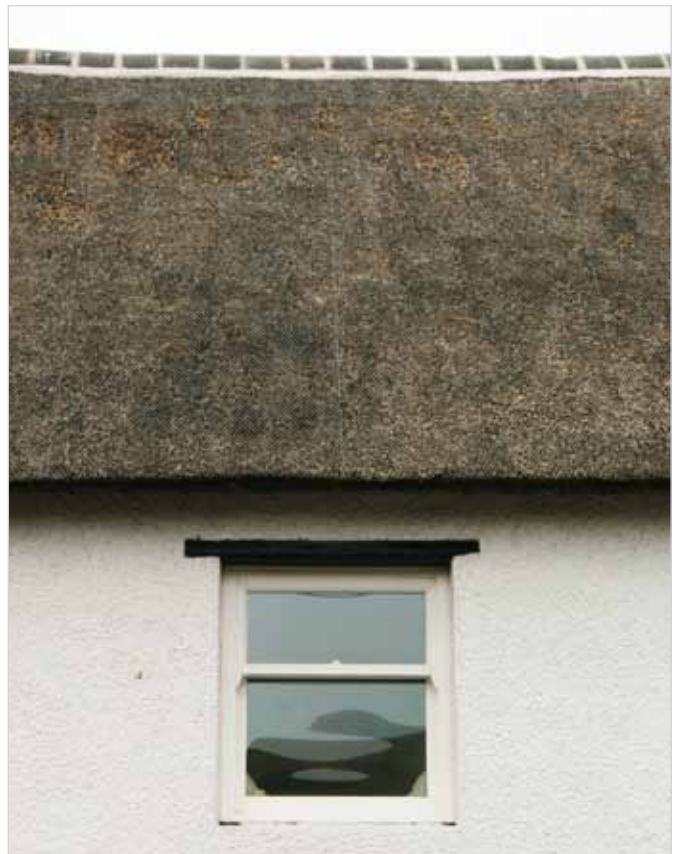
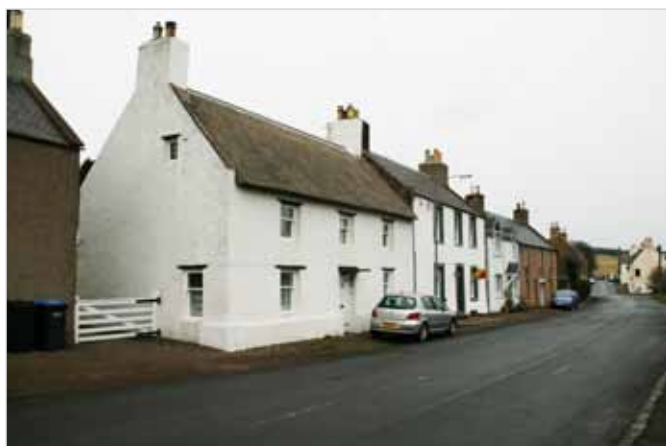
Mertoun Cottage – Scottish Borders

Condition of Thatch: ..... Good

Additional Notes: ..... Mid to late 18th-century two-storey cottage, listed as having a 'reed-thatched roof with tiled ridge coping'. The thatch is flush with the skewes to the south. Concrete copes have been added directly beneath both chimney stacks to the south and north and along the skewes, slightly overlapping the thatch. The thatch is entirely netted. Some slight compaction has occurred, which is visibly evident at the skewes where a gap has appeared between the thatch and the copes.

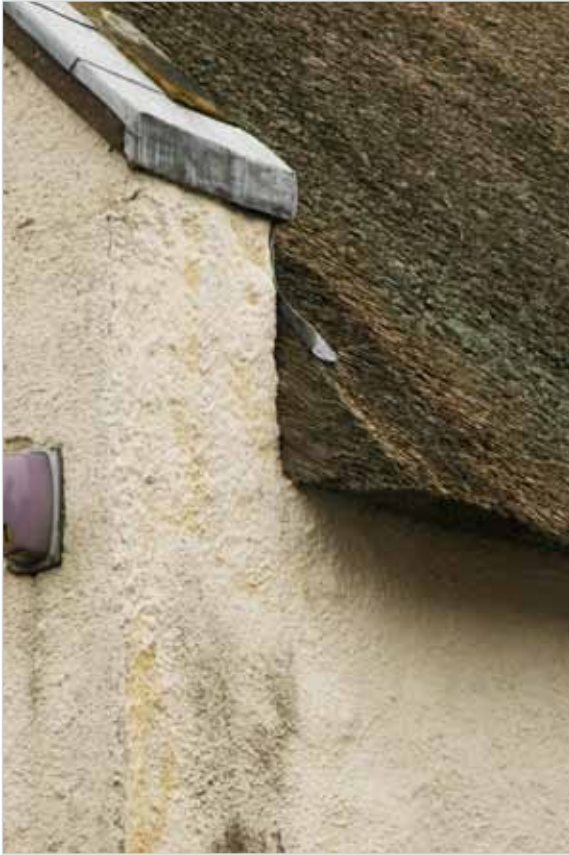
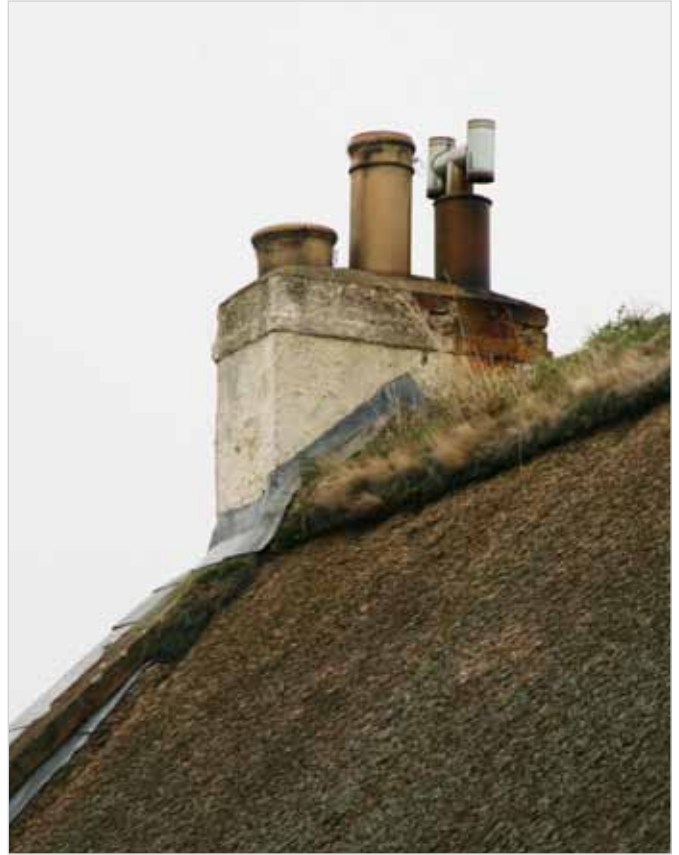
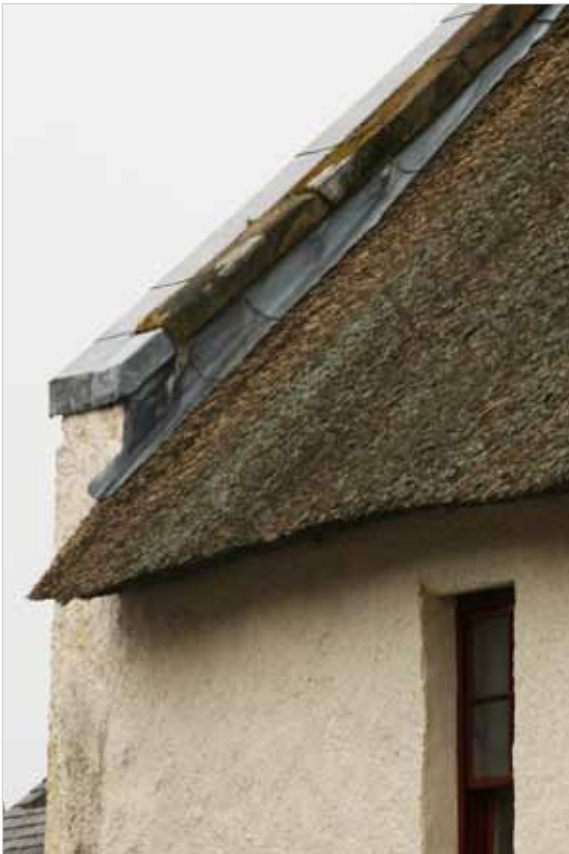
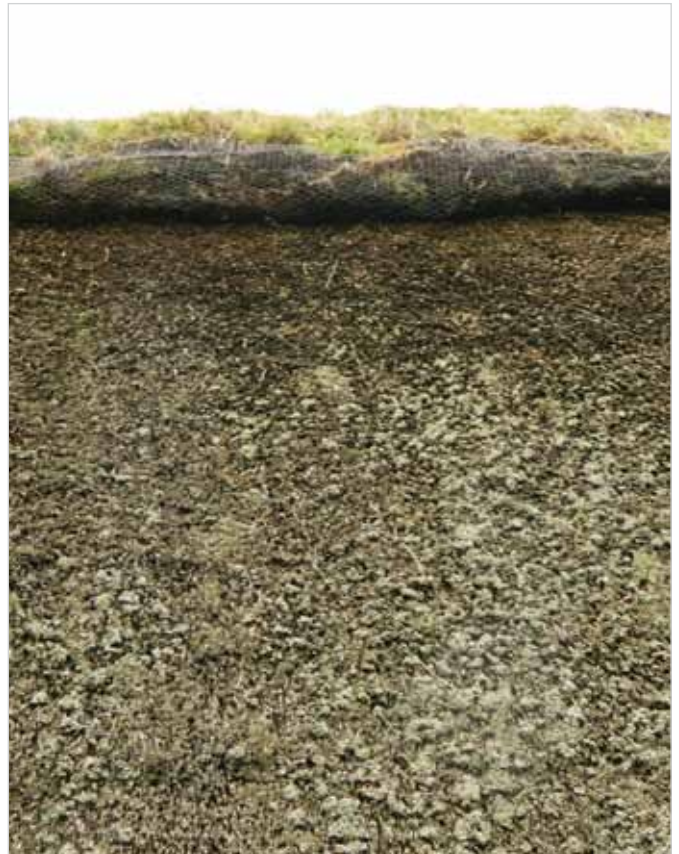
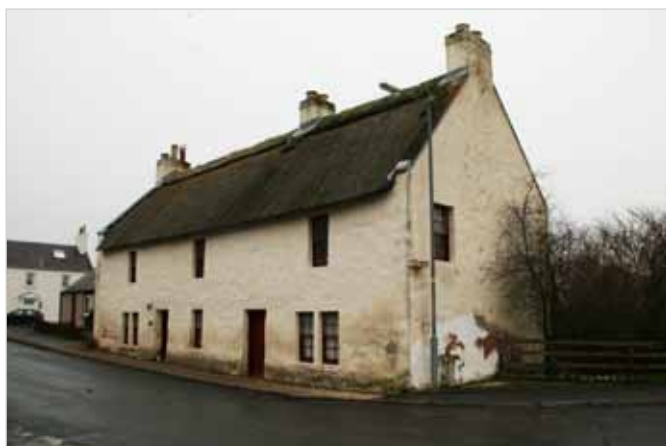
Myrtle Cottage – Scottish Borders

Condition of Thatch: ..... Good

**Additional Notes:** Early to mid 18th-century two-storey block comprising two cottages. The building has a steeply pitched reed-thatched roof with a turf ridge. The thatch is fairly shallow and is lower than the height of the skewers. The surface of the thatch has a large amount of mossy vegetation growth throughout. The turf ridge, which is continued below the three chimney stacks at a lower level, is netted, whilst the rest of the thatch is left uncovered. The turf has slightly grown through the netting at the ridge; however, it is in a good condition otherwise and remains intact. The building is located directly opposite another thatched cottage (Rose Cottage) and in

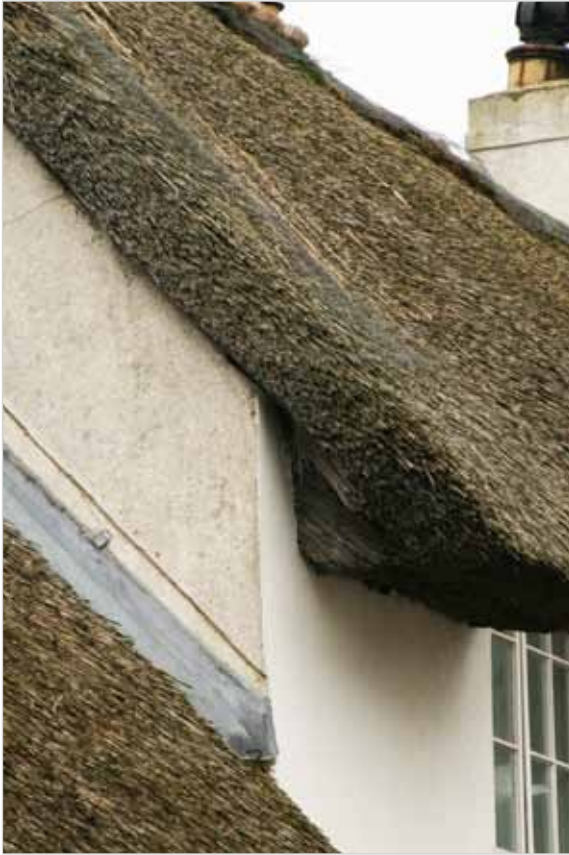
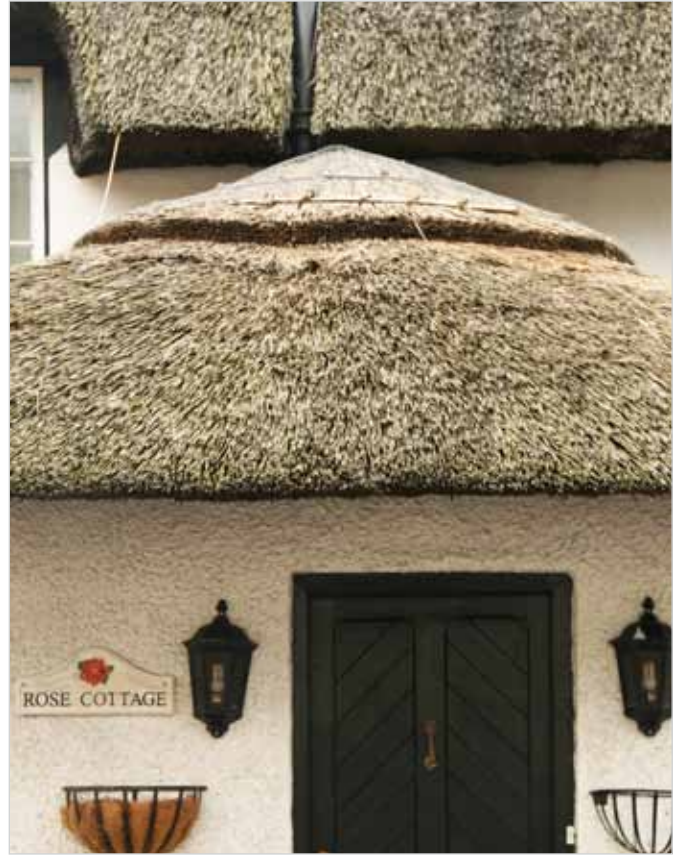
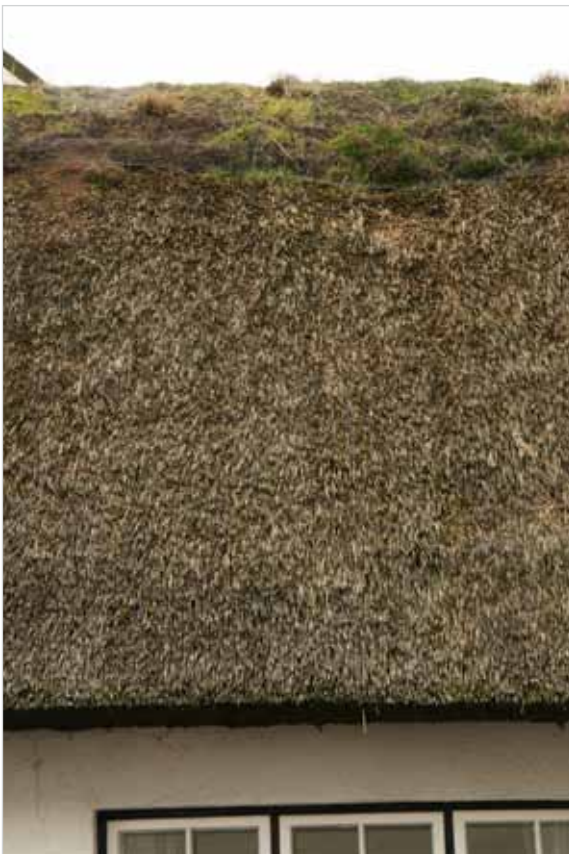
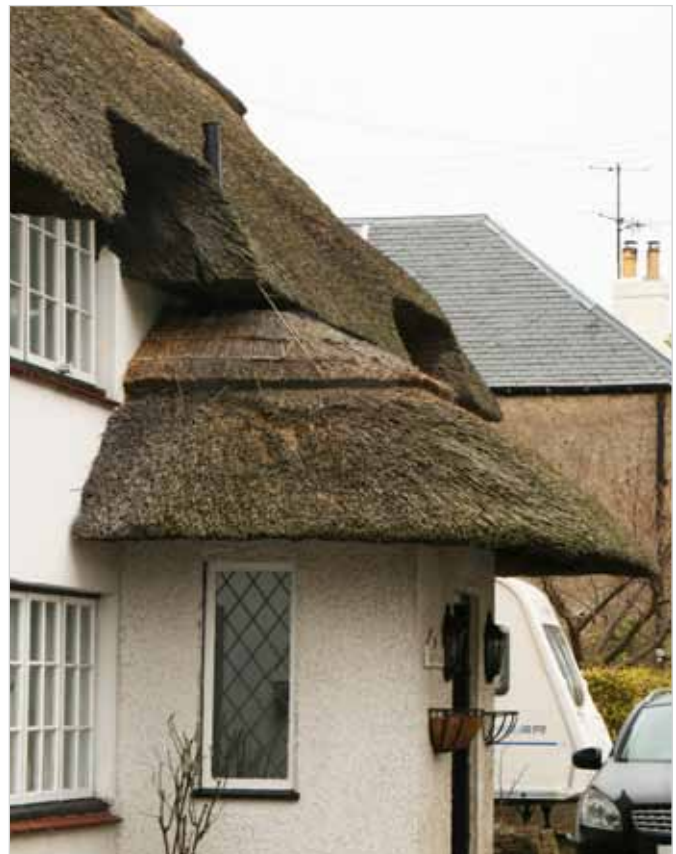
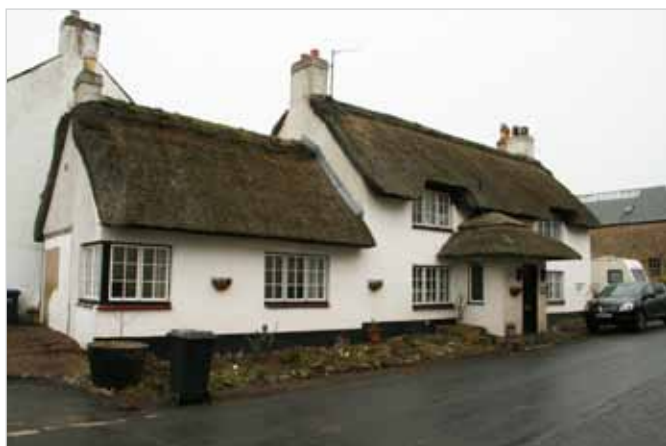
Rose Cottage – Scottish Borders

Condition of Thatch: ..... Good

..... above the first floor window openings. The turf ridge along both sections of the roof has slightly deteriorated in

..... roof is left uncovered. The condition of the thatch

..... as a whole is generally good, with only a few loose

..... strands of reed in places.

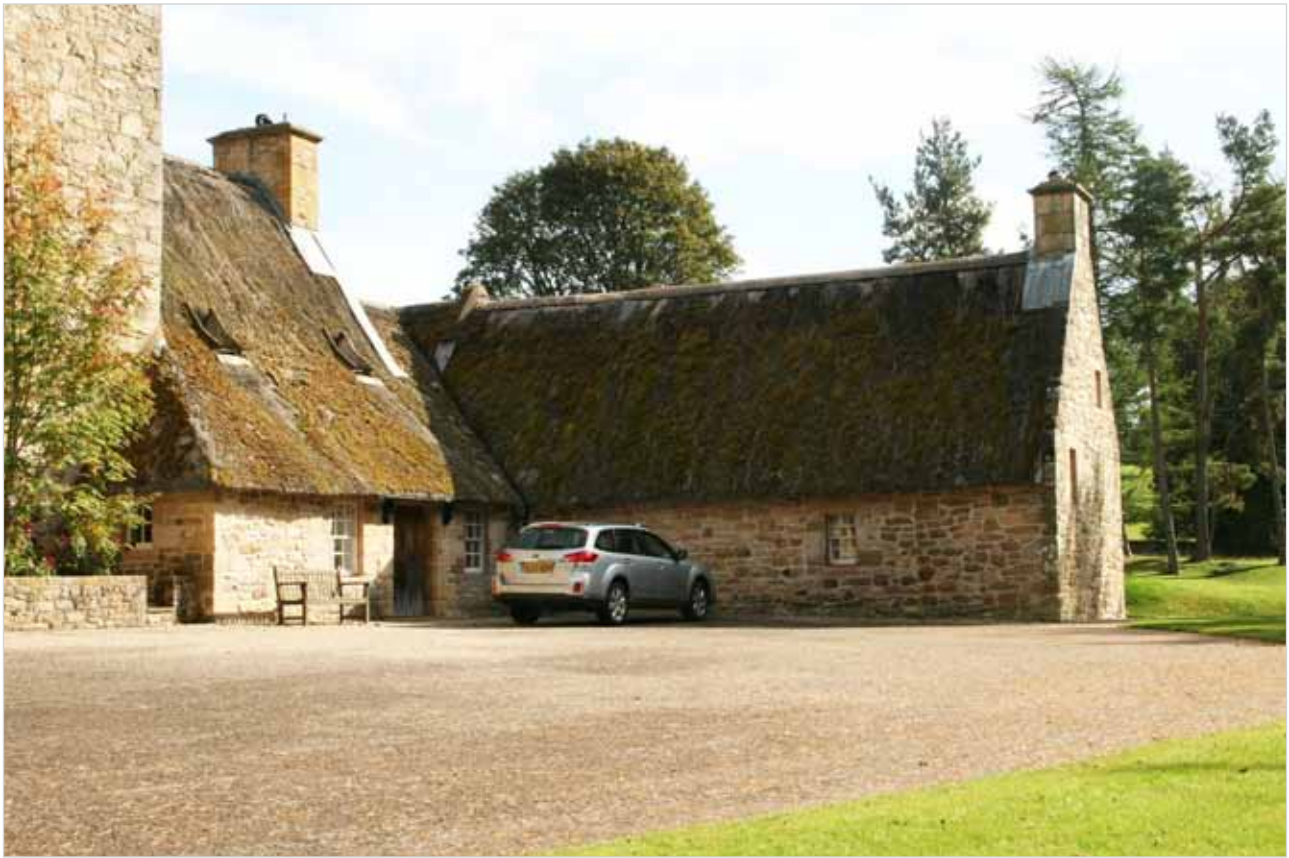
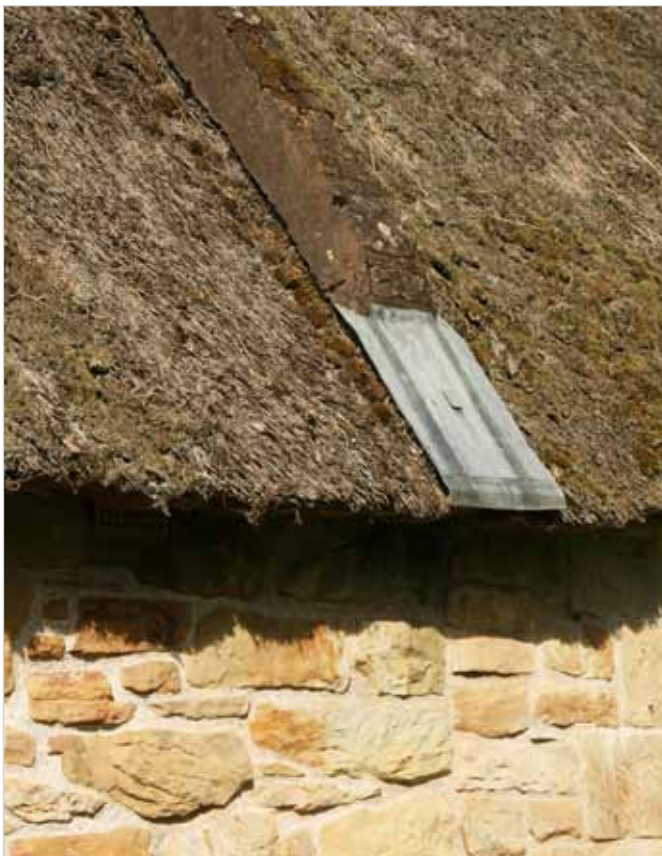
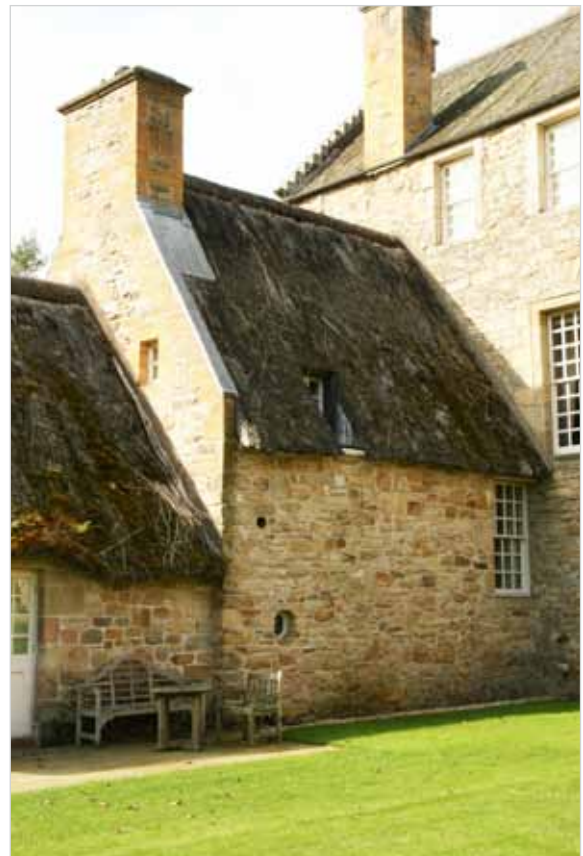
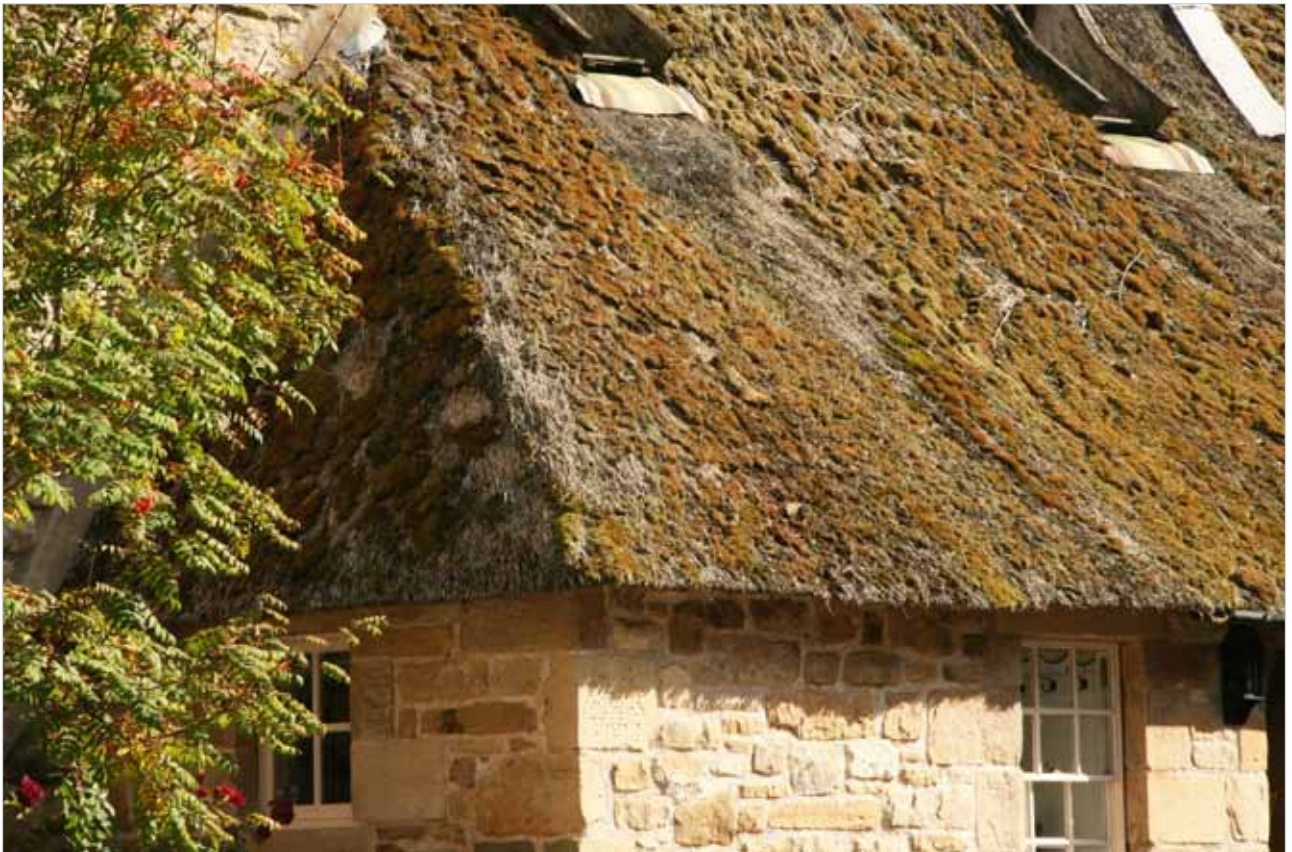
Ferniehirst Castle – Scottish Borders

Condition: ..... Fair

Additional Notes: ..... Ferniehirst Castle was built in the late 16th century and it is the single-storey L-plan former kitchen wing to the south that is currently thatched. Simpson & Brown Architects were hired in 1987-90 to renovate these buildings, which were roofless at the time. In July 2014 a planning application was submitted by the owners (Lothian Estates) to remove the thatch on the building and replace it with Scottish slate. It was supported by examples of other outbuildings on the estate that were also roofed in Scottish slate. In October 2014 the planning application was granted permission, subject to a number of conditions regarding the materials and finishes used on the re-roofing. There are two window openings set into the thatched roof, two facing south-west and one facing north-east. The L-plan wing appears to have been extended at some point and this would explain the concrete cope that is present partway along the roof. None of the thatch has been netted. Some areas have had lead flashings installed, directly below the chimney stacks, copes and window openings. The eaves have been moulded slightly above some of the window openings on the south elevation and above the door opening on the east elevation. The thatch is in fairly poor condition, with many loose reeds on the surface of the roof, a large amount of mossy vegetation growth and general deterioration throughout. Work to remove the thatch is likely to begin soon and the wing will be slated.

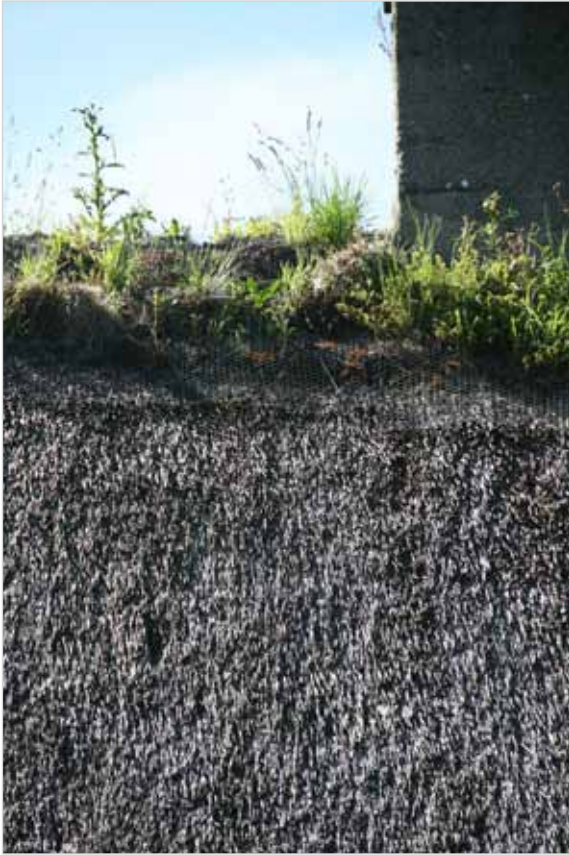
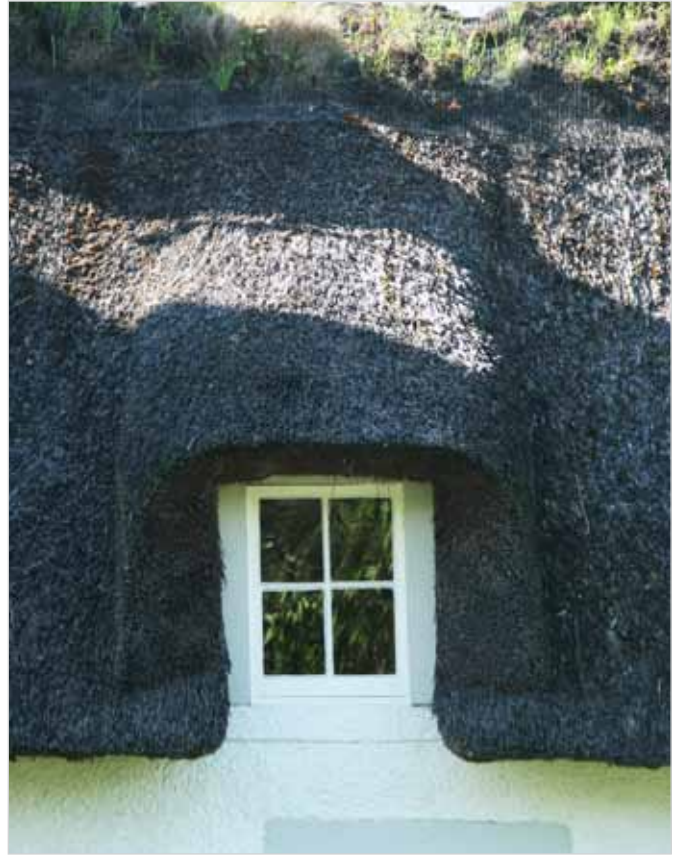
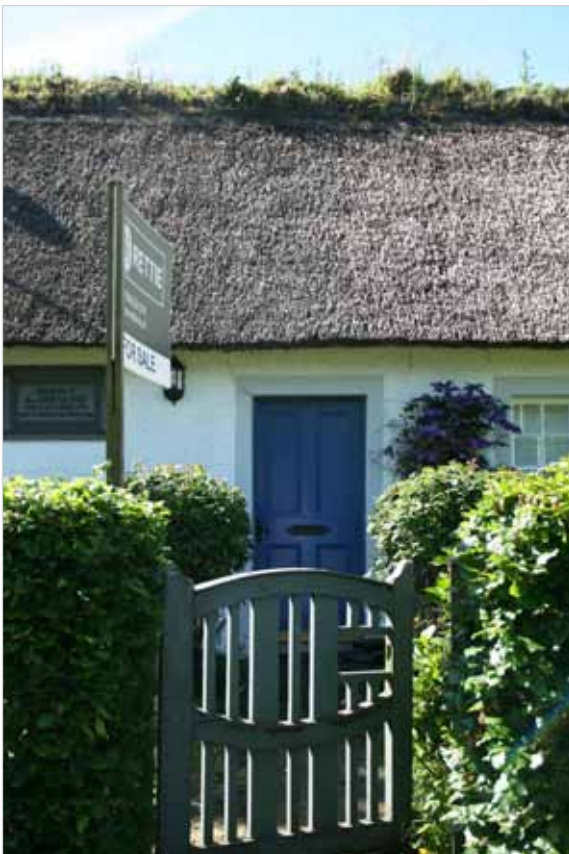
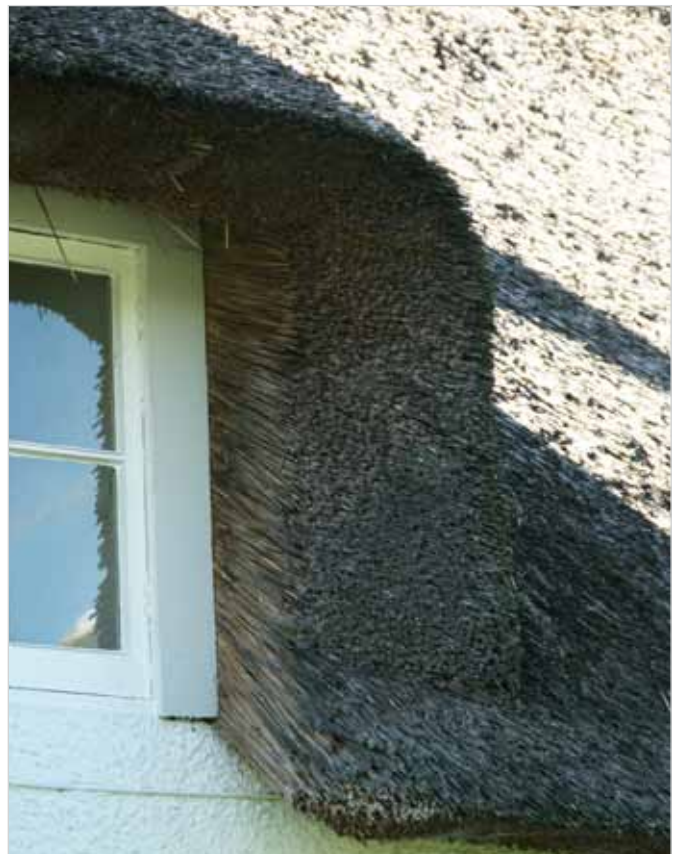
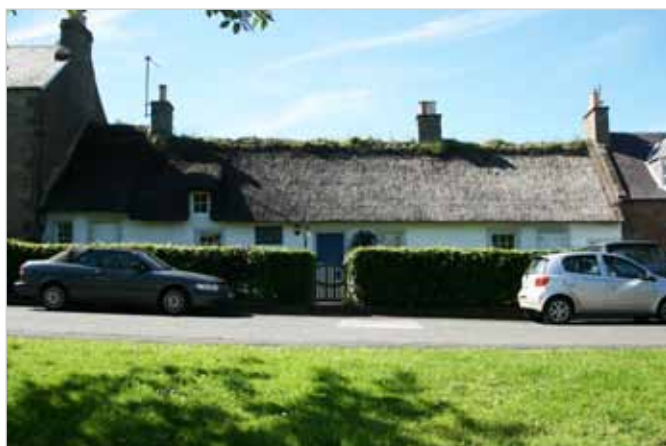
Leyden's Cottage – Scottish Borders

Condition of Thatch: ..... Good

dormer'; however, the building currently has three dormer windows, one in the front elevation and two in the back elevation. The thatch is raised and sculpted around the dormer window openings. At the time of surveying, the building was up for sale.
